Investigation of Shell Offshore Inc. Hobbit Pipeline Leak Ship Shoal Block 281 January 24, 1990

Gulf of Mexico
Offshore Louisiana

Alex Alvarado
Gerald Daniels
Stephen Ledet
Carl Walker

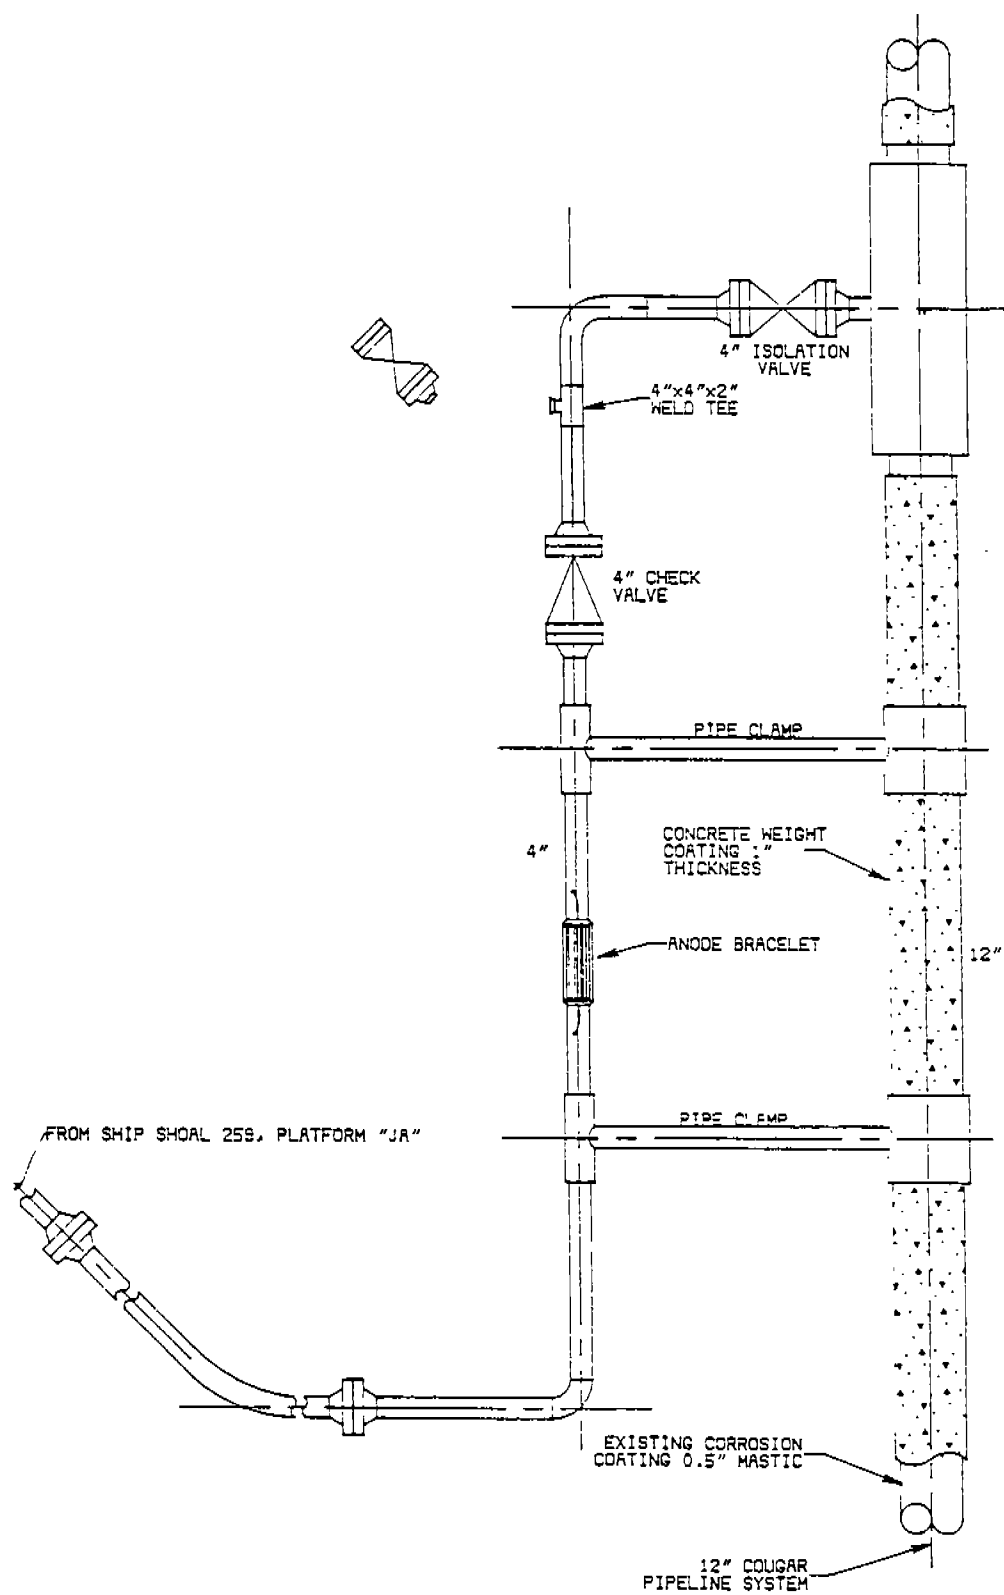
Hobbit Subsea Tie-in Assembly

Cal-Dive International in Morgan City, Louisiana, was contracted to locate and repair the leak. In the early afternoon of January 25, 1990, an inspection of the SSTI by Cal-Dive International revealed that a 2-inch valve on the 4-inch SSTI assembly had been separated from a 4-inch by 4-inch by 2-inch reducing weld-tee. The valve and the parted flange were found on the sea floor approximately 18 inches from the SSTI assembly (see Attachment 2).

On January 25, 1990, a few minutes after leaving the dive bell, the diver found the source of the leak. The 2-inch ANSI¹ 900 flange and valve had been broken off a 4-inch by 4-inch by 2-inch reducing weld-tee on the SSTI assembly. The flange and valve were lying on the seafloor approximately 18 inches from where they were originally attached. According to the

The diver reported that the SSTI assembly was covered with approximately 12 inches of sand and deteriorated pieces of burlap bags. The sand bags that were originally over the top of the manifold were rotten and disintegrated. He noted that three parts of the assembly were protruding above the sand cover and surmised that the actuator on top of the 2-inch valve had also been exposed prior to the spill. He reported that the sand had been scoured out of an area approximately 2 feet in diameter where the valve had been attached. The scour appeared to have been caused by flow from the break.

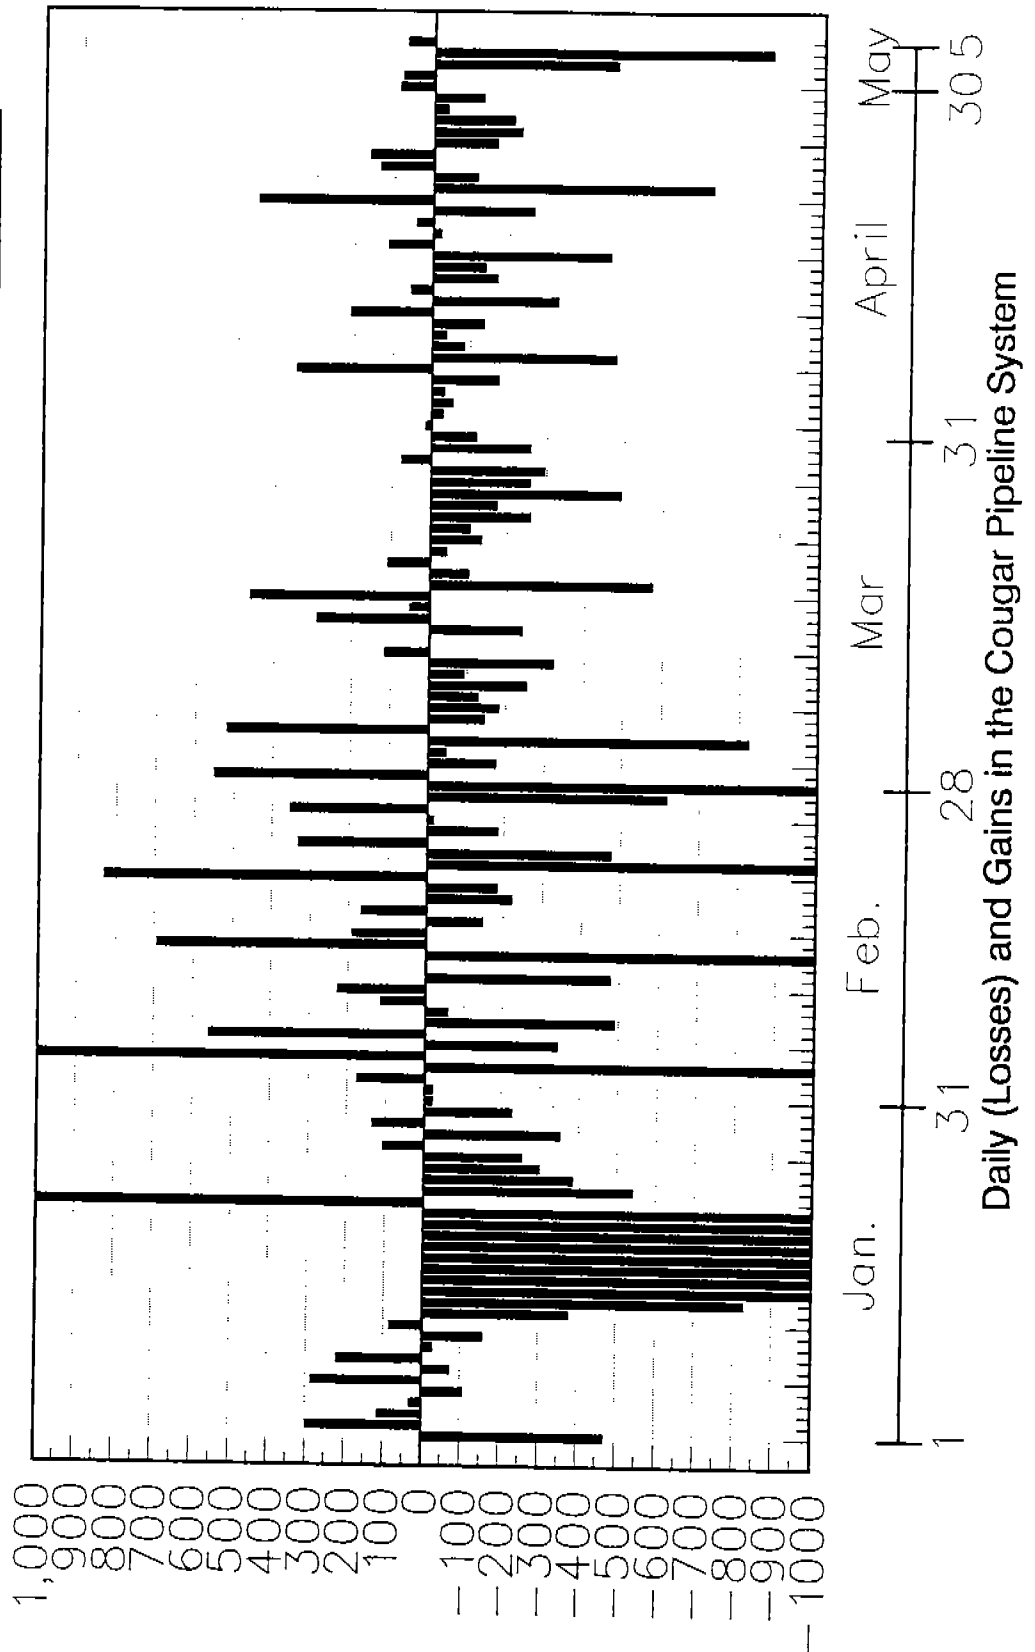
Tabulation Of Daily Losses And Gains In The Cougar Pipeline System

Table 1 lists the actual losses and gains of the Cougar Pipeline System throughput, as calculated by the investigating panel members using run tickets from each input source and the readings from the check meter at Ship Shoal Block 208 for the beginning of 1990. (Graphical representation of this data can be found in Attachment 4.)

Upon reviewing this data, considerable losses, indicative of an upset in the system, can be seen for the 12-day period from January 12, 1990, through discovery of the leak on January 24, 1990. This prompted the panel to investigate the high probability that oil had leaked from the pipeline for several days prior to its discovery. Although this information was available to SPLC, the huge shortage was not discovered until tabulation of the data after January 31, 1990. Despite the fact that the Cougar Pipeline System had a slight tendency to show a shortage during the first quarter of Calendar Year 1990, the losses shown in Table 1 lead the panel to believe that a significantly larger amount of oil had been spilled than was present on the water surface on January 24, 1990.

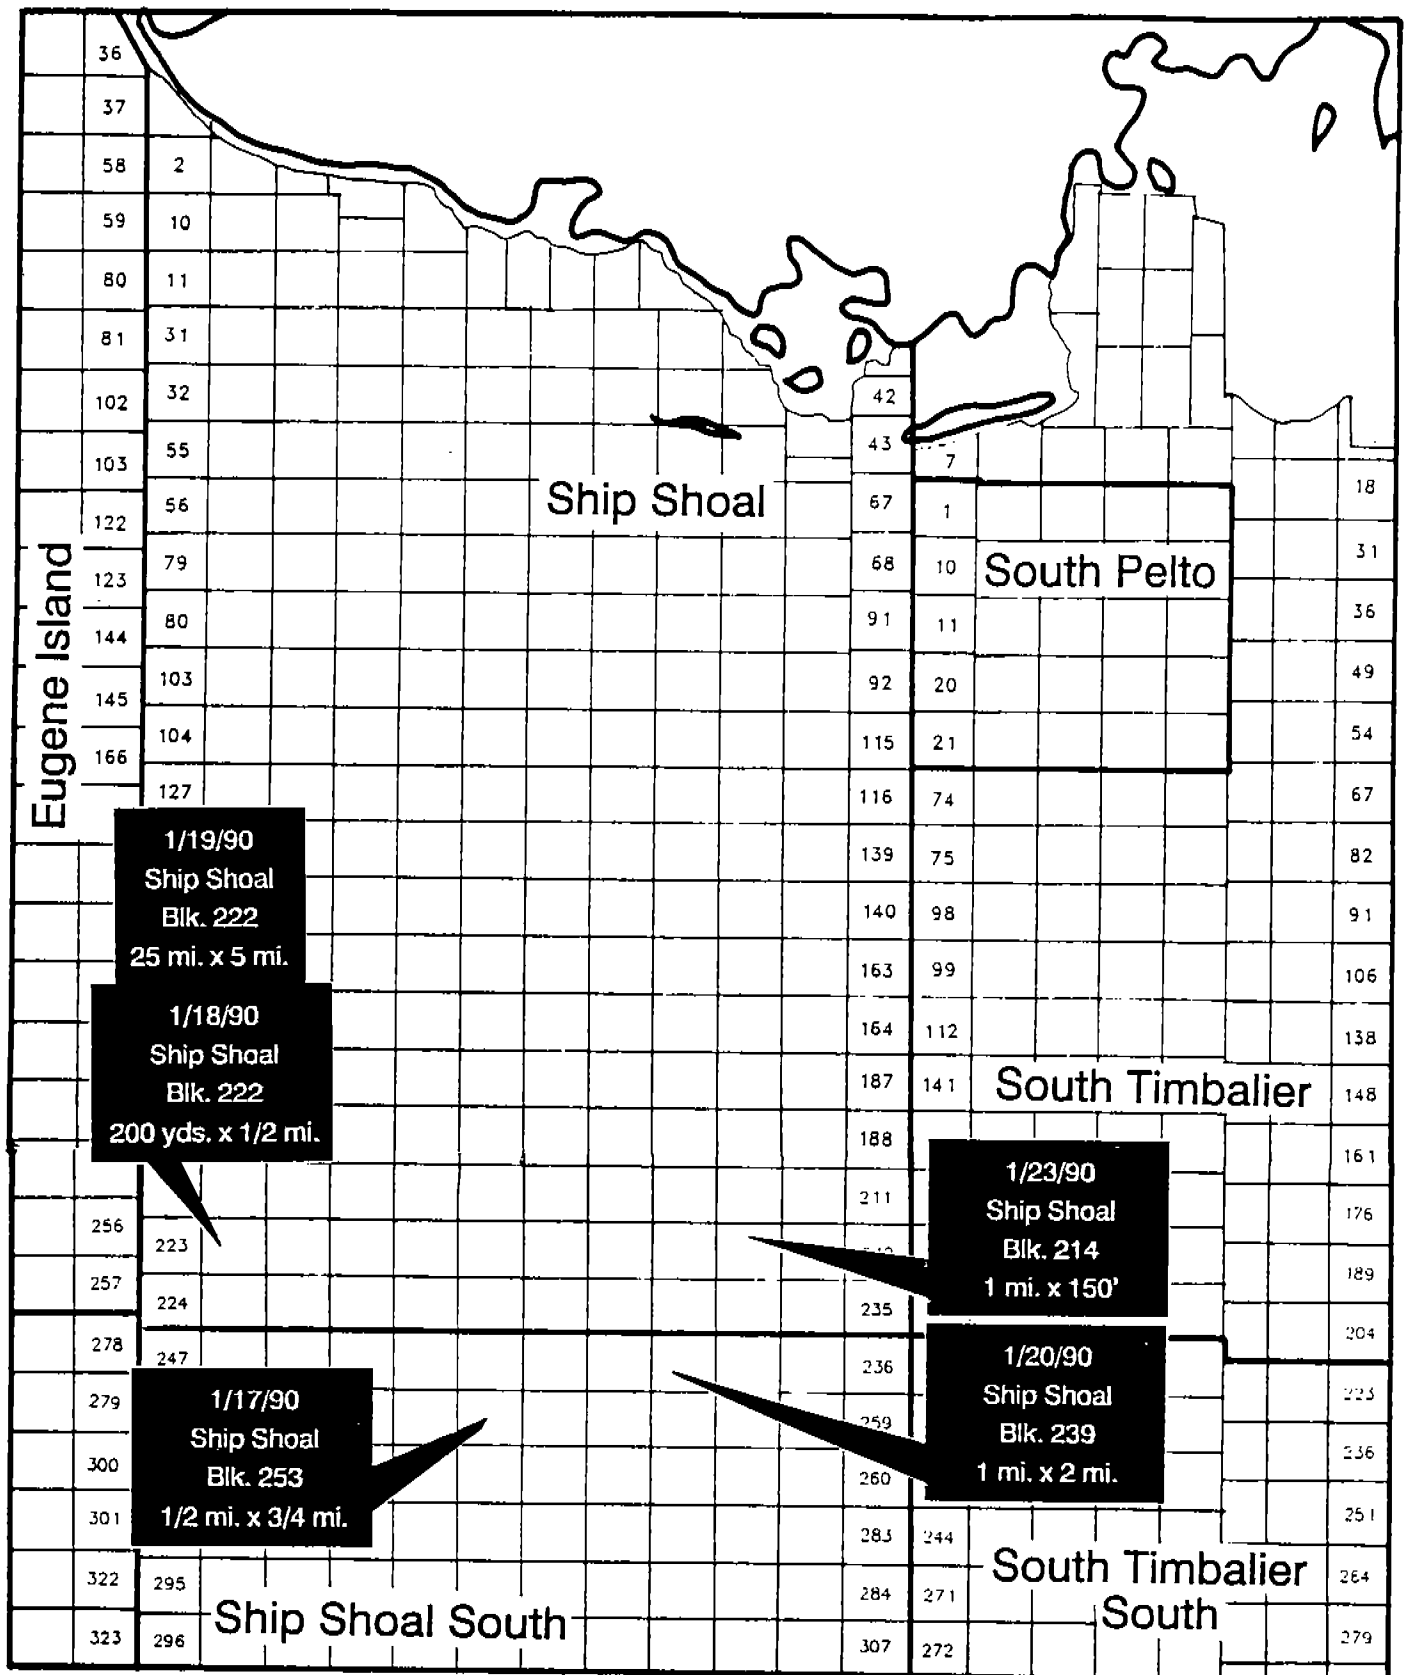
Projected Trajectories of Cougar Pipeline Oil Spills

The prevailing weather data for this period and a trajectory analysis simulating both a continuous leak and batch release of oil during the 12-day period were also reviewed. The plotting of the trajectory information and the unidentified sightings supported the theory that the pipeline had probably intermittently spilled varying quantities of oil over a period of several days (see Attachment 5).

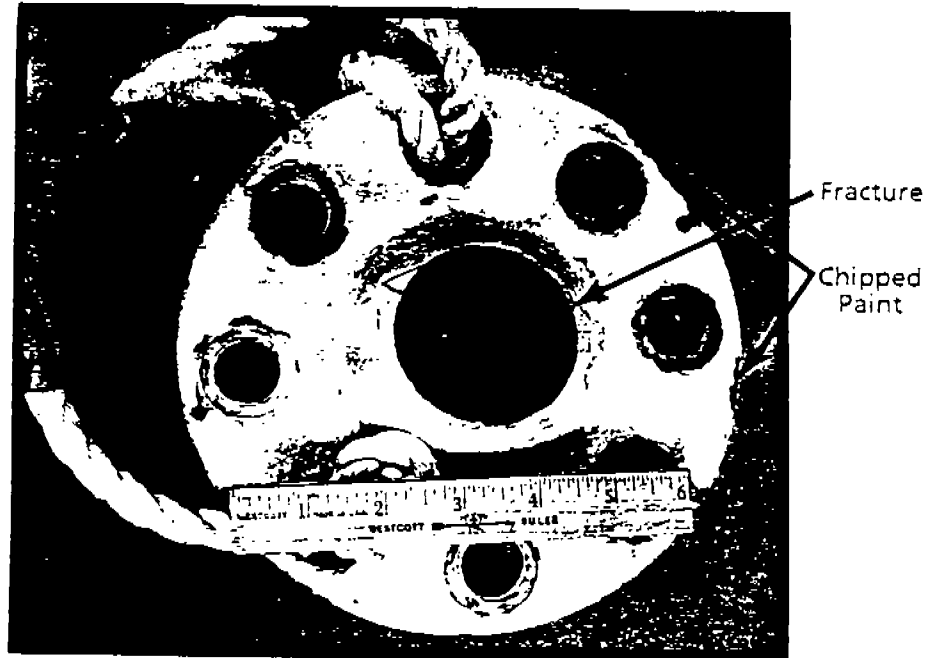
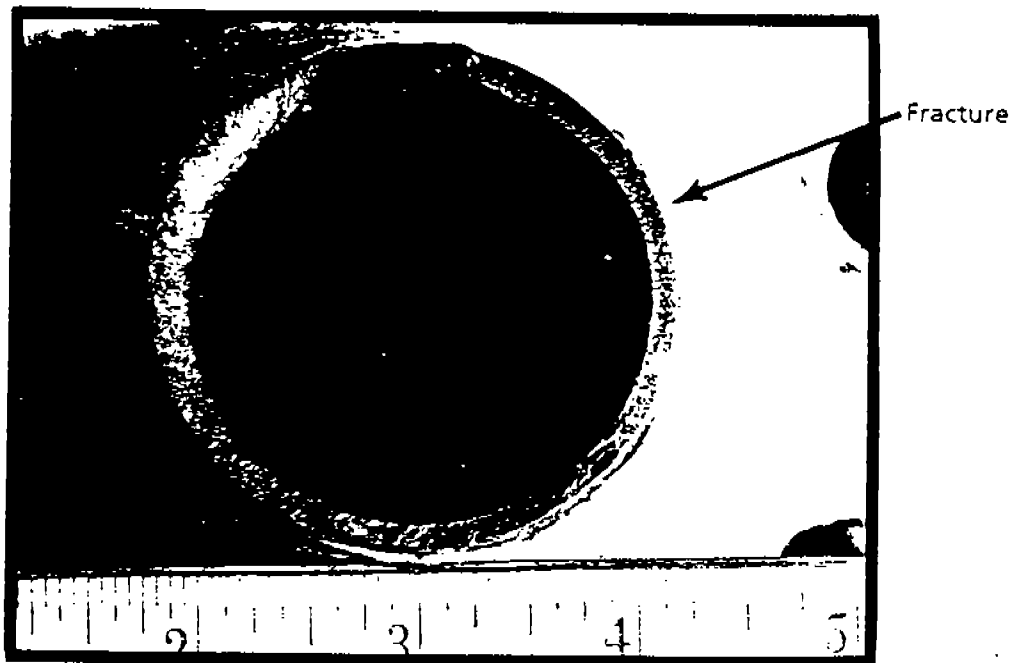
Fractured Flange from Subsea Manifold, Cougar Pipeline

The break in the weld-tee was fairly clean in the heat-affected zone and almost perpendicular to the center line of the flange. The repair crew believes the damage was caused by an anchor or a cable of a fishing net that hooked the 2-inch valve handle and broke it off. However, there was no indication of anchor scars in the vicinity of the SSTI.

"Our analysis of the failure indicates that large tensile or bending loads would have been necessary to fracture the flange; the load from the cantilevered components would be insufficient to have caused the failure. Although we saw no evidence of any mechanical damage to the flange, it is possible that the cantilevered ball valve may have been pulled by something such as an anchor."

The fracture at the weld neck was in the area of minimum cross-section. Wall thickness measurements made approximately 1/4 inch from the fracture varied between 0.140 inch and 0.199 inch. The nominal thickness of a Schedule 40 flange is 0.154 inch.

The entire fractured surface was at 45° to the axis of the flange, suggesting an overload-type failure. No evidence of any flat fractures, typical of what might be encountered in fatigue, could be found (see Attachment 6).

- The metallurgical and failure analysis, as well as the initial diver's survey, identified the cause of the damage to the pipeline as external forces exerted on the 2-inch valve.

- Due to the absence of anchor scars around the SSTI assembly and the lack of external damage to the 2-inch valve, the consensus of the panel is that the 2-inch valve was protruding from the sand covering and was snagged by cable from a fishing net or anchor.

- The MMS should investigate the applicability of pipeline leak detection systems other than low-pressure sensors.
- The MMS should modify current regulations to require improved protection of subsea appurtenances and periodic inspection of all subsea appurtenances to ensure adequate protection from damage.
- The MMS should immediately issue a Safety Alert to notify all lessees and pipeline ROW holders of the potential problems with protecting subsea appurtenances.
- The SPLC and other operators associated with the Cougar Pipeline System should immediately implement an automated or manual system of routinely balancing deliveries and receipts at a frequency greater than once daily.
